**CERCLA
EXPANDED SITE INSPECTION**

**LEFTON IRON & METAL
East St. Louis, Illinois
ILB984809244
L0570250003**

**PREPARED BY:
ILLINOIS ENVIRONMENTAL PROTECTION AGENCY
BUREAU OF LAND
DIVISION OF REMEDIATION MANAGEMENT
OFFICE OF SITE EVALUATION**

September 6, 2005

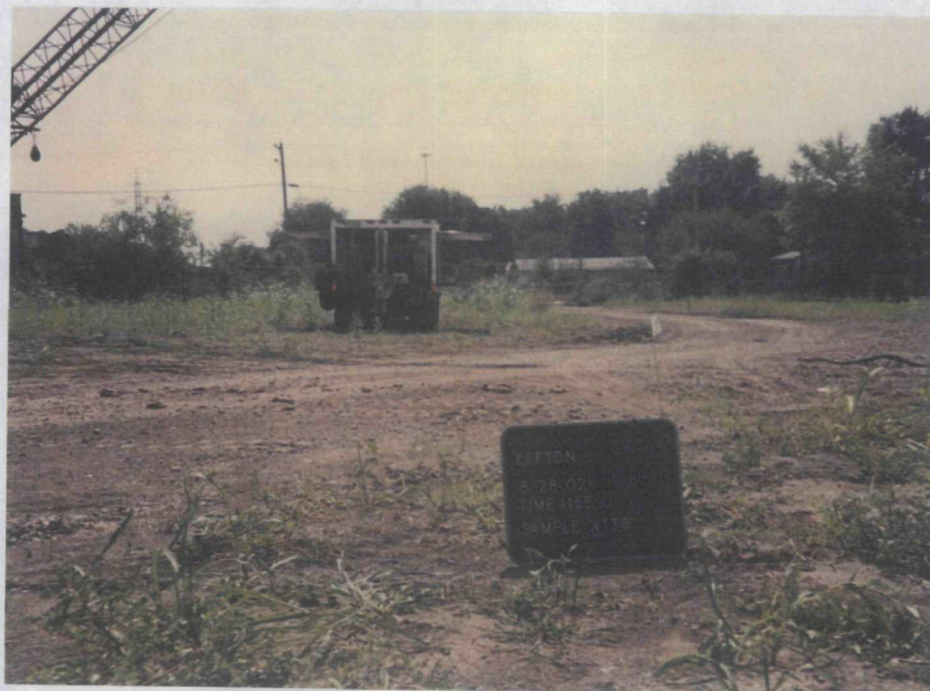
COMMENTS: Photograph of soil sample X138. X138 was collected from the main scrap yard area of the 17th Street facility.

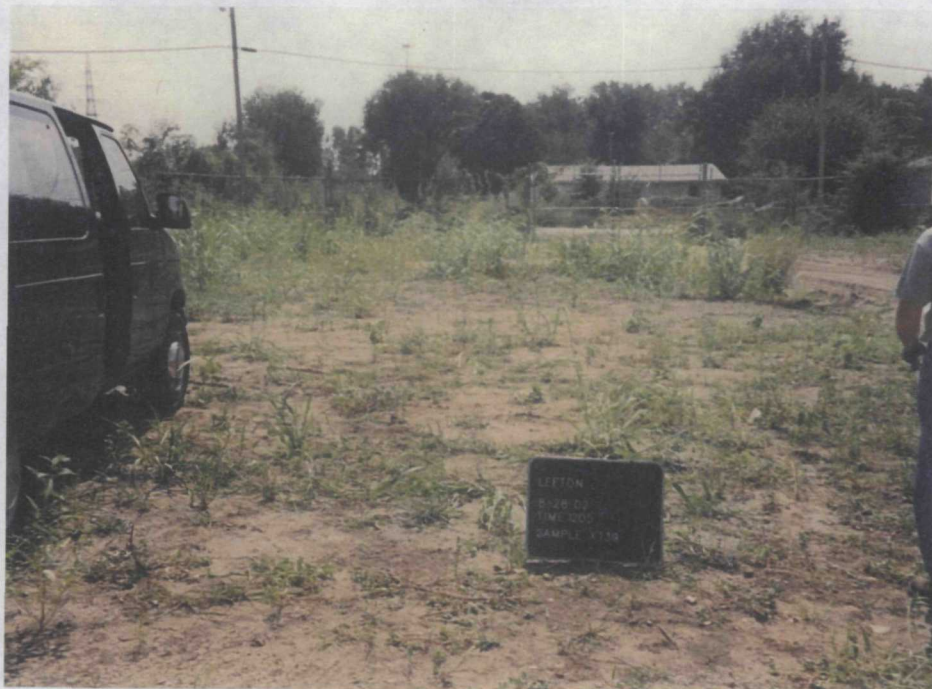
COMMENTS: Photo of soil sample X139. X139 was collected from a location from which a rail spur entered the 17th Street facility.

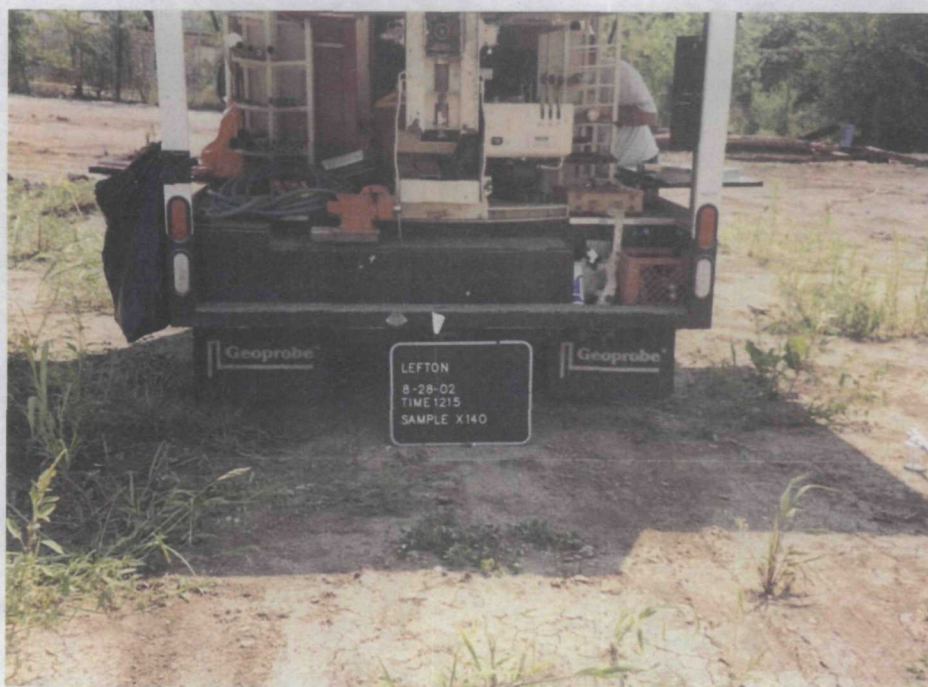
COMMENTS: Photograph of soil sample X140. X140 was collected from the southwest corner of the 17th Street facility.
